TS-PIC-201104013S  
June 2012

AERIAL PHOTOGRAPHIC ANALYSIS OF  
BARITE HILL/NEVADA GOLDFIELDS

McCormick, South Carolina

Interim Report

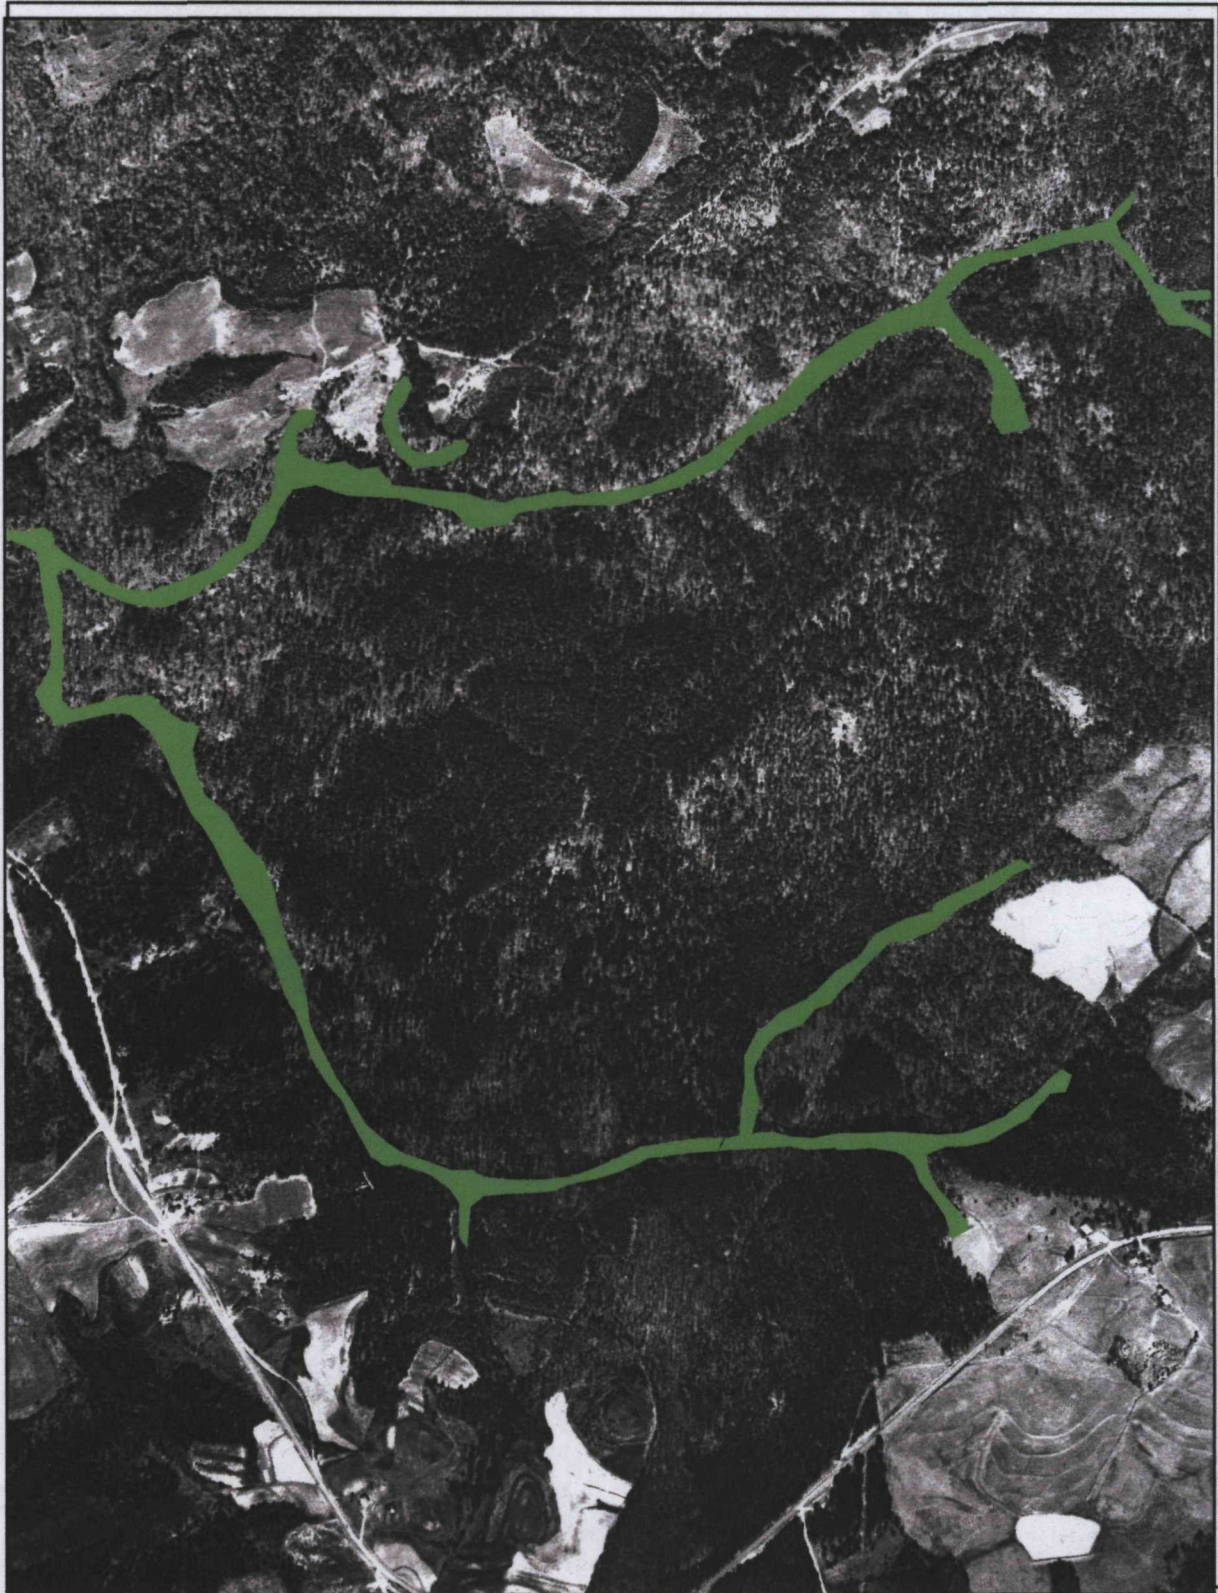
Pre Barite Hill Mine Site  
Adjacent Riparian Wetland, 1959

The 1959 photograph shows the condition of the site prior to the establishment of the Barite Hill mining operations. The probable wetlands adjacent to the site are restricted to the natural creek bottoms.

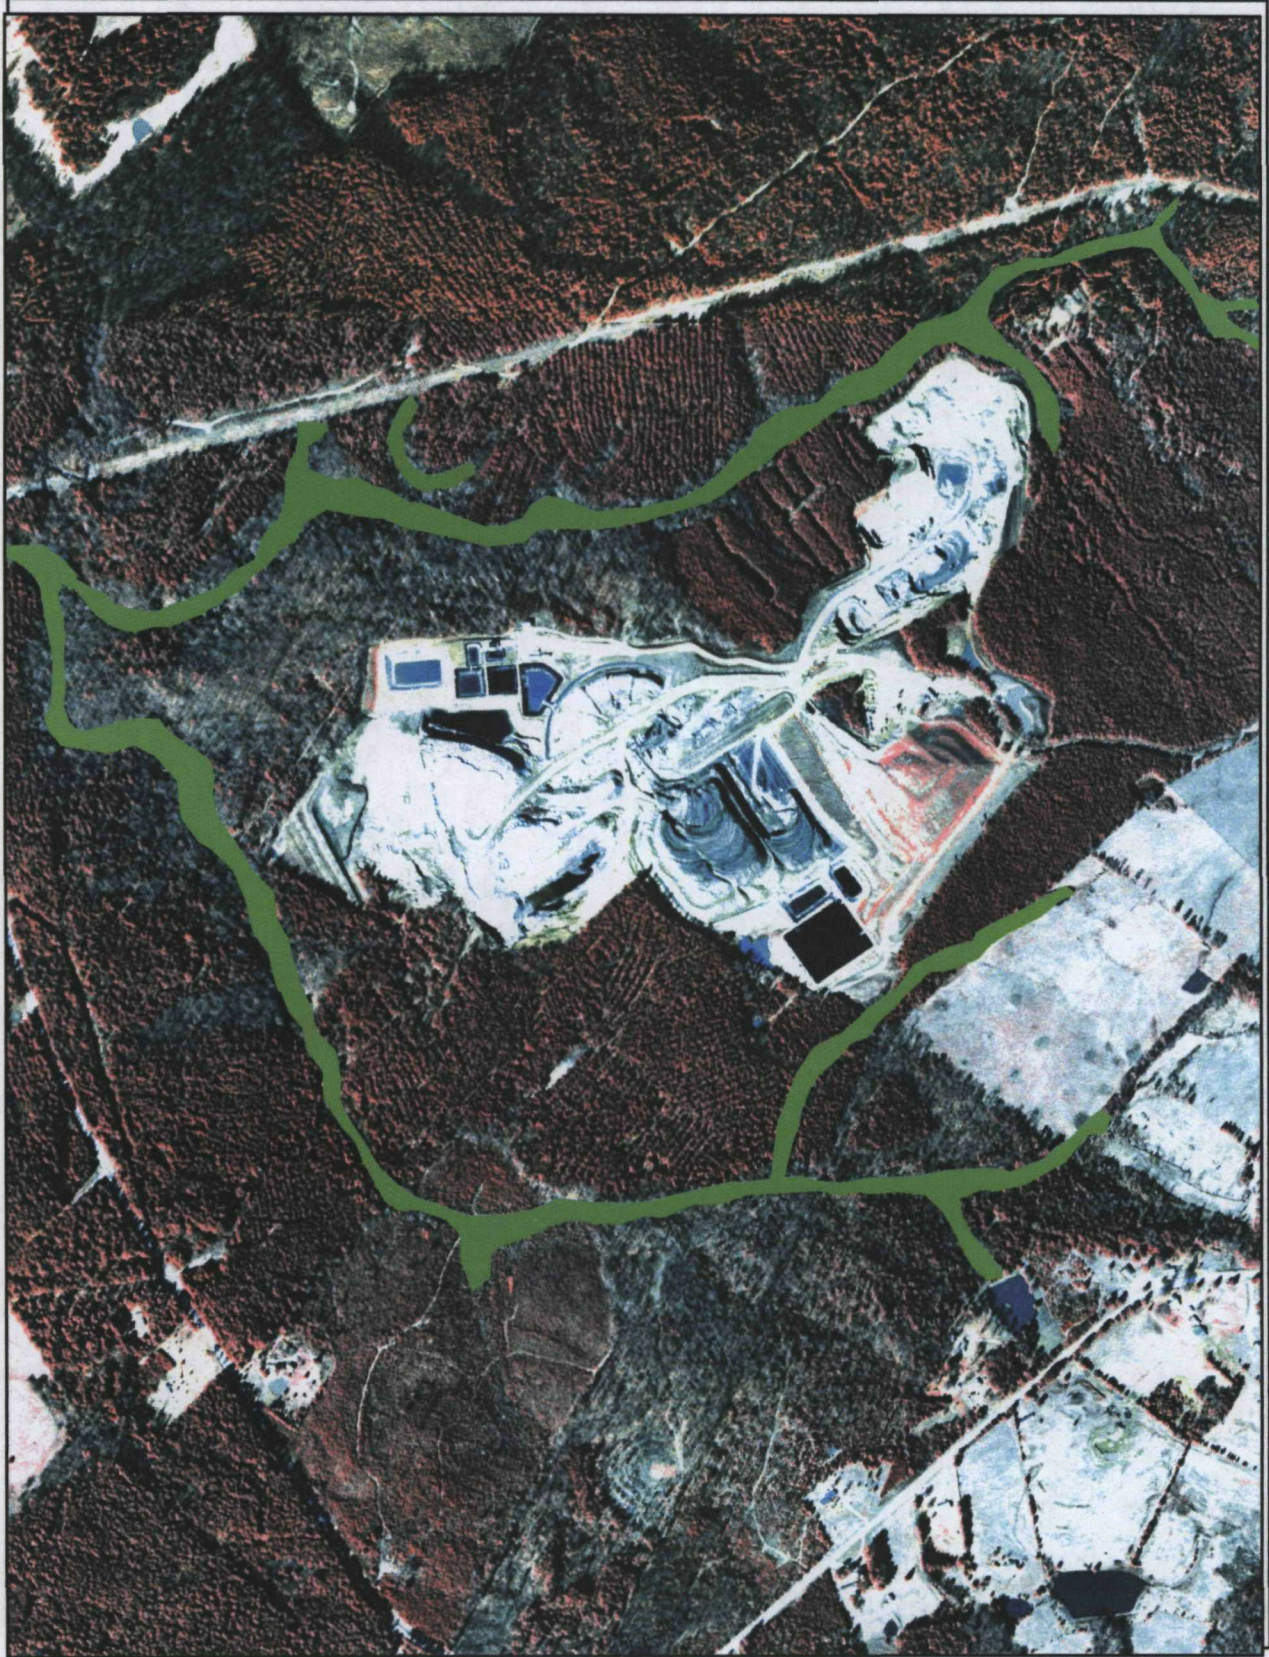
# Barite Hill Mine Site Adjacent Riparian Wetland, 1994

Photo analysis determined that the presence of probable riparian wetlands remain at the natural creek bottoms as observed on the 1959 photo after the establishment of Barite Hill mining operations. Pollutants can be potentially transported by rainwater runoff. These wetlands may be threatened by potential contamination.

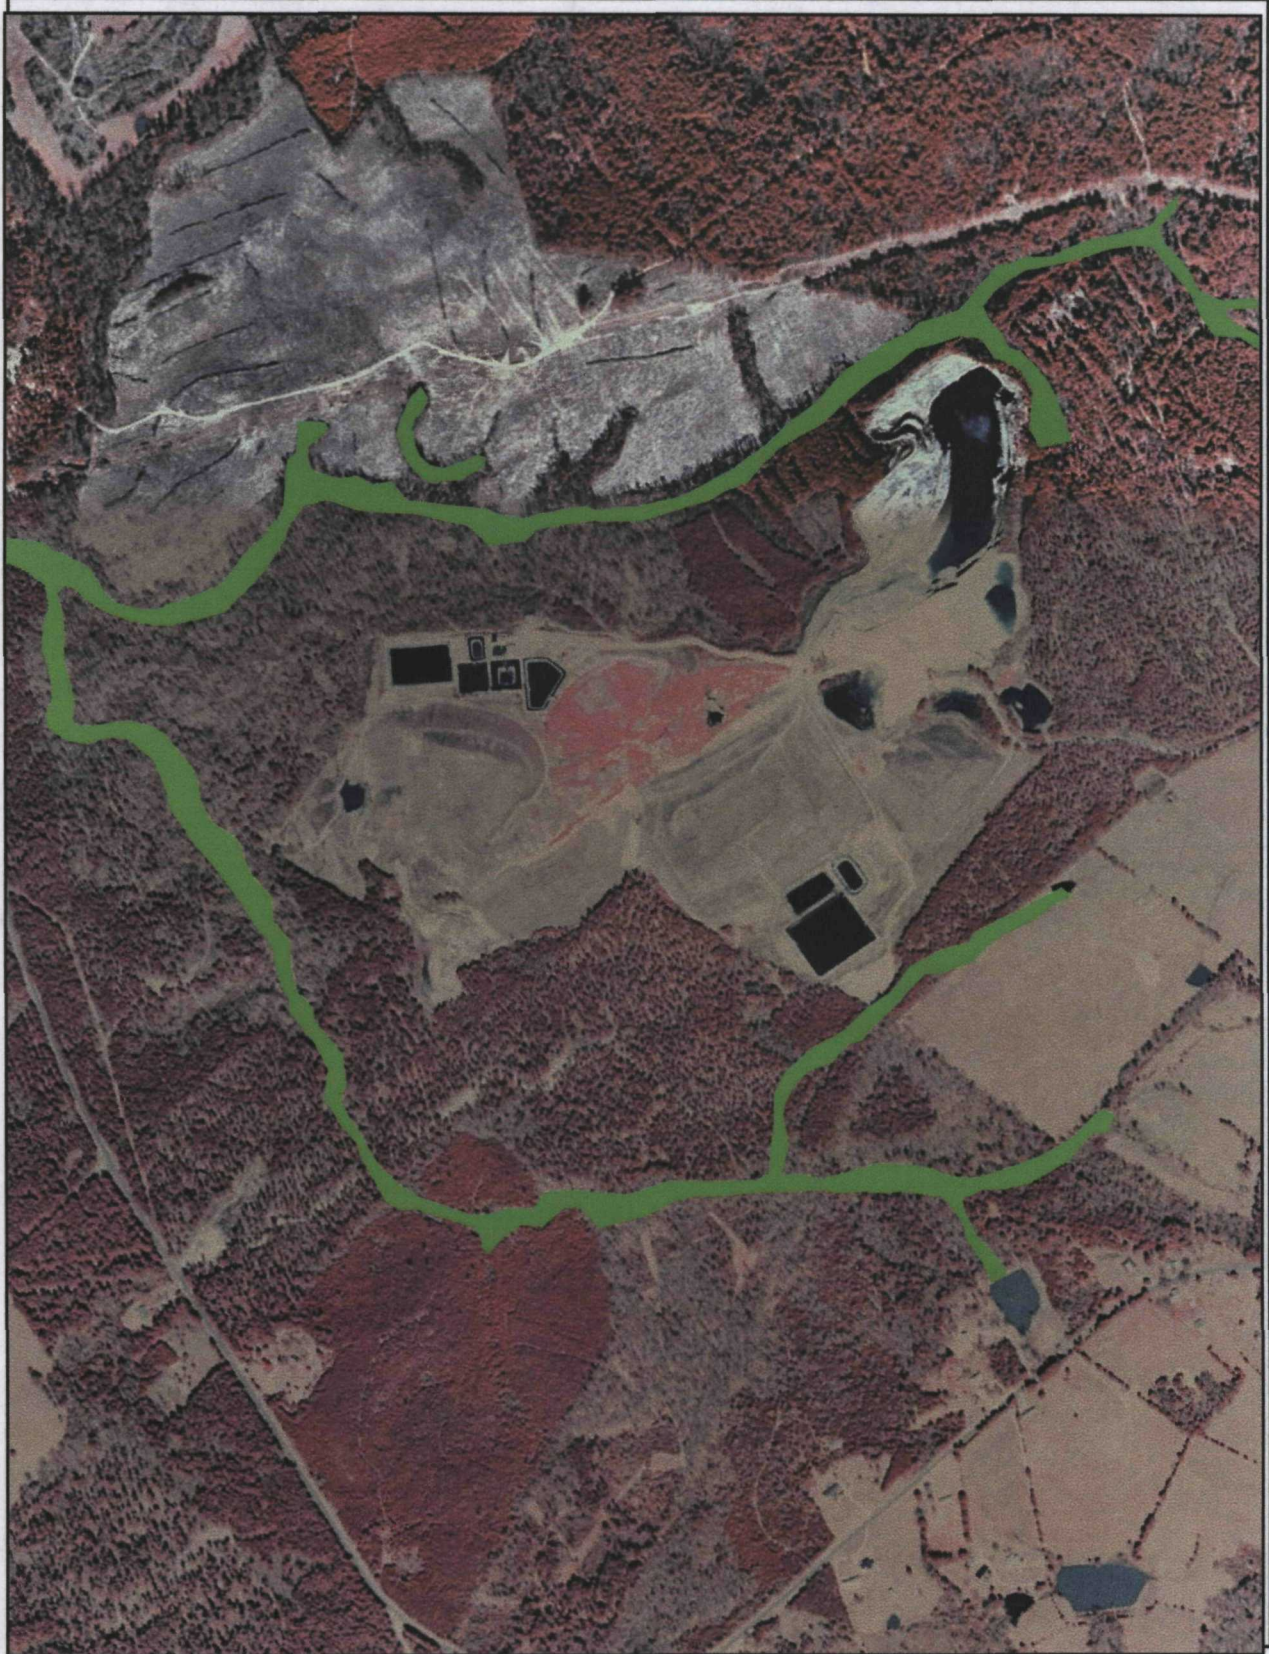
# Barite Hill Mine Site Adjacent Riparian Wetland, 1999

Photo analysis determined that the presence of probable riparian wetlands remain at the natural creek bottoms as observed on the 1994 photo. There has been no significant change in the probable wetlands from 1994 to 1999.

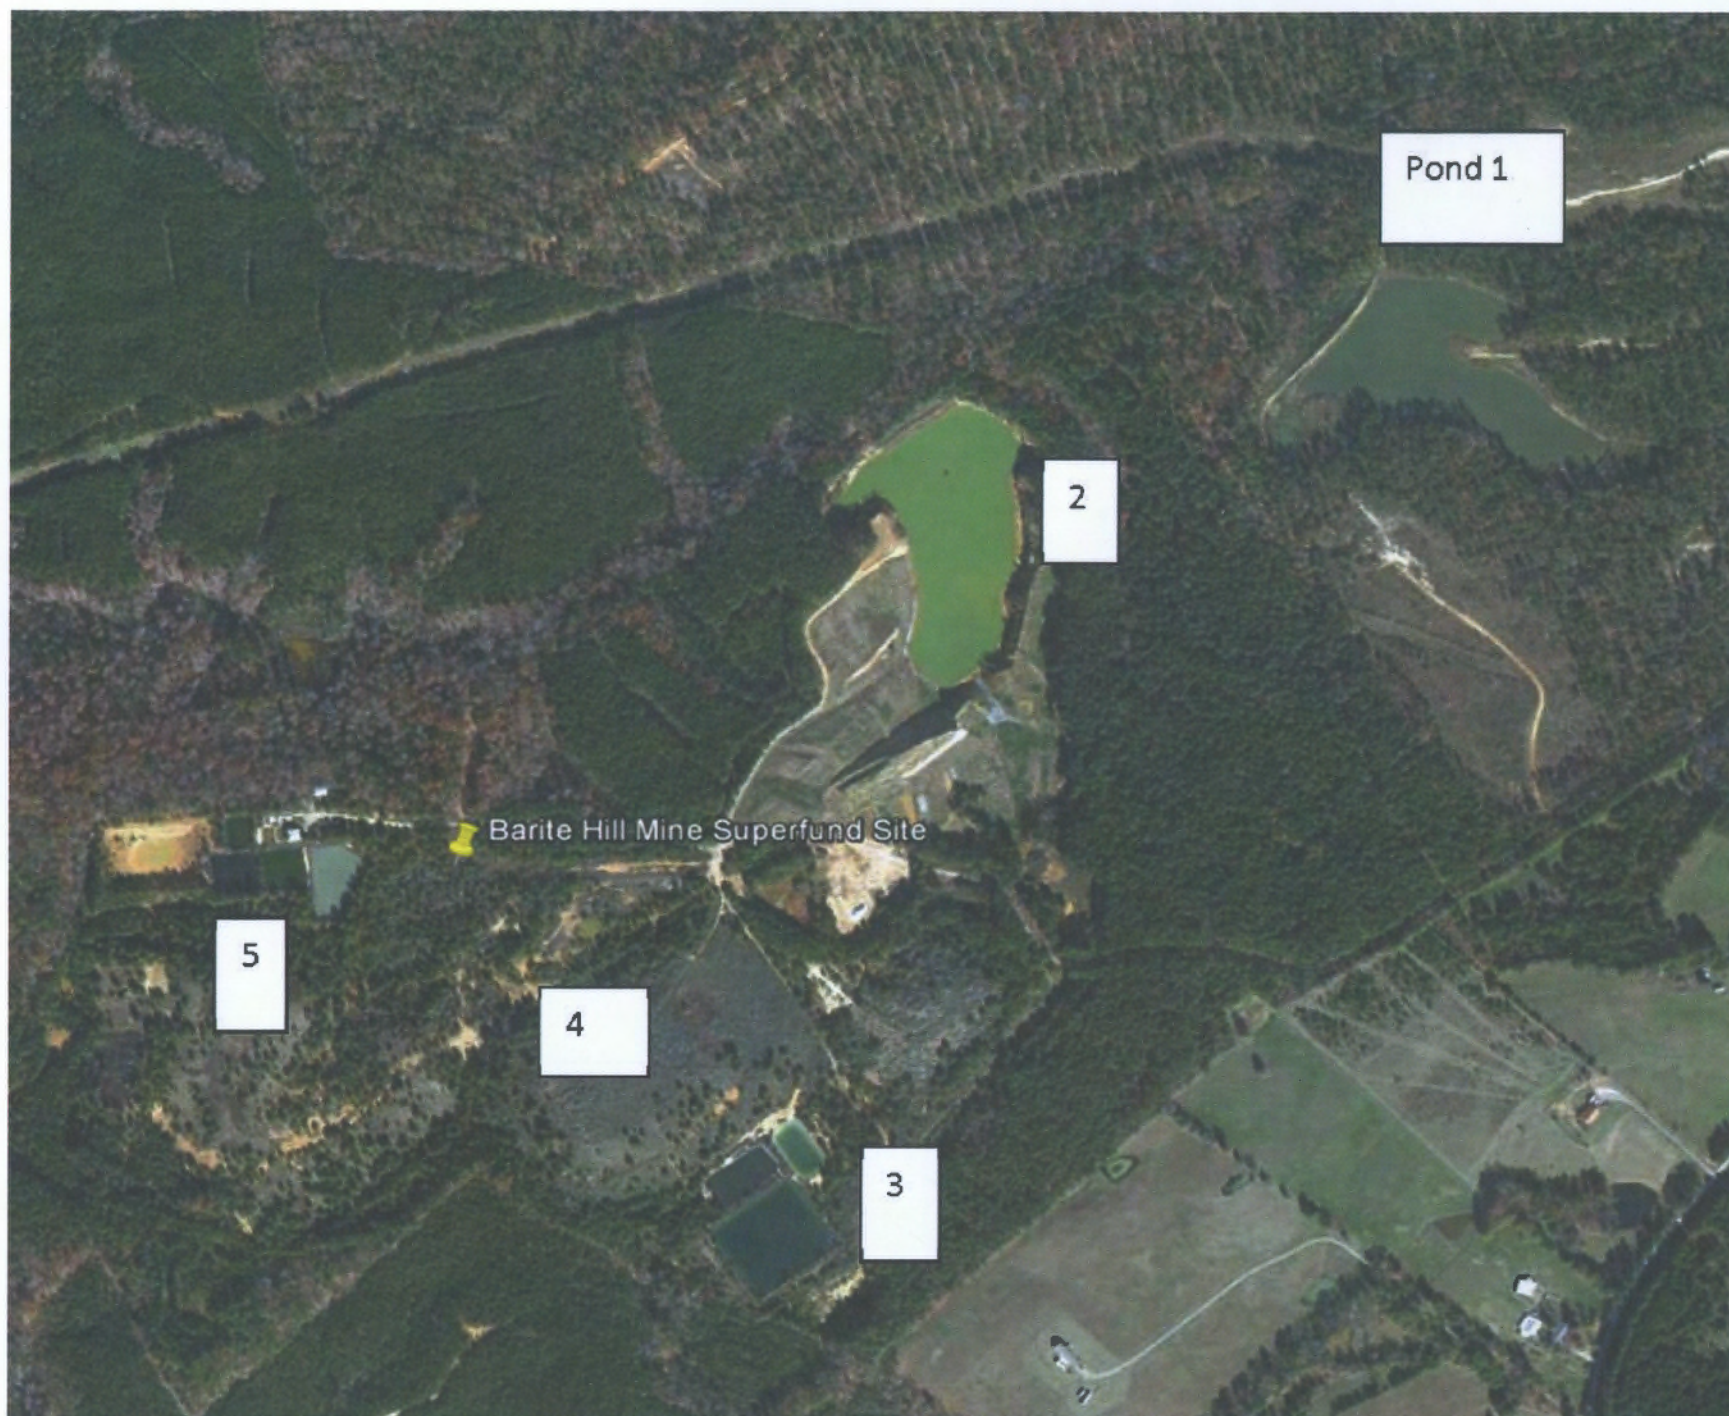
The images used for this analysis were made from black-and-white infrared scanner data. The equipment used during this inspection was the Inframetrics Thermacam PM 390. This instrument is a focal plane array thermal imaging system with temperature measurement capabilities of -14 F to 2732 F. Accuracy, as stated by the manufacturer, is  $\pm 2\%$  or 2 degrees C. The sensitivity is  $< 0.18$  F @ 86. Normal color film records reflected energy in the blue, green, and red portions of the electromagnetic spectrum. Black-and-white infrared scanner data differs in that it is sensitive to reflected energy in the infrared portions of the electromagnetic spectrum. For example, features that are highly reflective in the infrared portion of the spectrum, such as healthy vegetation, appear in shades of gray on the black-and-white infrared image. These portions are referred to as the "spectral reflectance characteristics" of the feature. No interpretation of the true color of a particular feature can accurately be made from black-and-white infrared image, and a knowledge of the spectral reflectance characteristics of that feature is required. This information is not readily available for the majority of features identified in this report. Therefore, unless otherwise indicated, no attempt has been made to interpret the features identified on the black-and-white infrared images.
